Models	1990-93 300ZX
Section	Service Campaign
Classification	P4120
Bulletin No.	NTB94-096
Date	October 20, 1994

VOLUNTARY SERVICE CAMPAIGN ON 1990-93 300ZX IGNITION POWER TRANSISTOR UNIT

APPLIED MODEL All 1990-1993 300ZX (Z32)

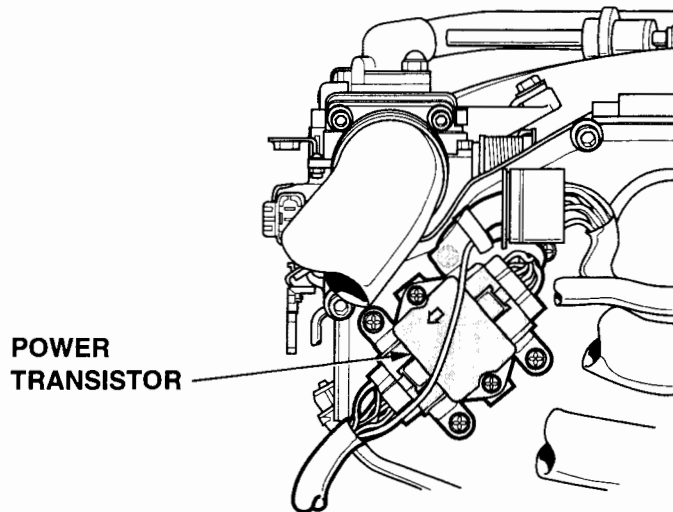
An electrical problem in the power transistor unit may cause poor driveability and/or rough idle. A counter measure power transistor unit has been developed to resolve this incident.

1. Open the Hood.
2. Remove the air ducting to the throttle body.
3. Disconnect the power transistor harness connectors.
4. Remove the four bolts holding the power transistor to the timing belt cover.
